EVALUATION OF MACHINE VISION COLLECTED PAVEMENT MARKING  
QUALITY DATA FOR USE IN TRANSPORTATION ASSET MANAGEMENT

A Thesis

Major Subject: Civil Engineering

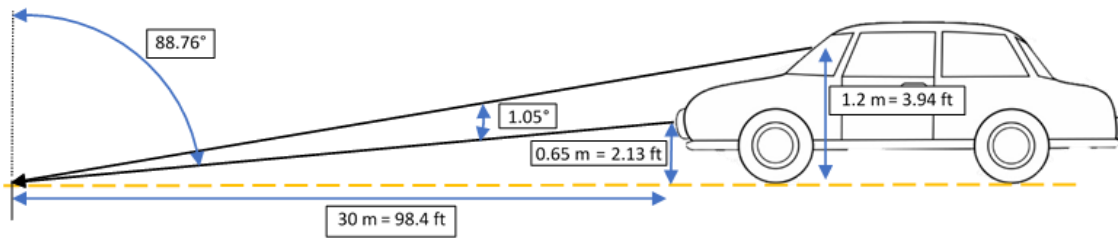
**Figure 1. Standard 30-meter Retroreflectivity Measurement Geometry**

measured by the coefficient of  $R_L$  in units of millicandelas per square meter per lux ( $\text{mcd}/\text{m}^2/\text{lux}$ ). The standard specifications for measuring retroreflectivity are designed to measure at a point 30 meters ahead of a vehicle to simulate the driver's observation of the road at night (5). Retroreflectivity can be measured using both handheld and mobile retroreflectometers which are produced in many different models by several manufacturers. The standard retroreflectivity measurement geometry is based on a European vehicle which has a headlamp height of 0.65 meters and a driver eye height of 1.2 meters (5). Figure 1 shows the standard retroreflectivity geometry.

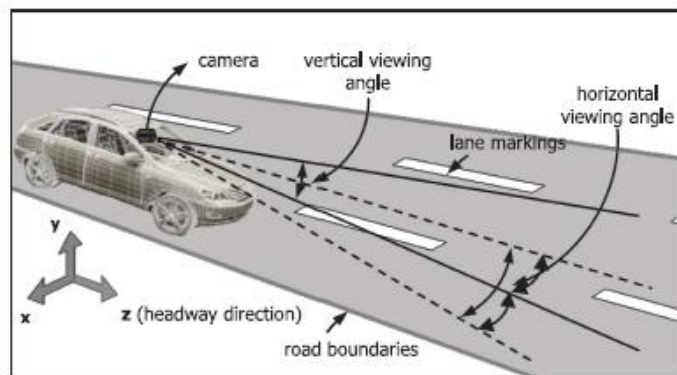
**Figure 2. Vision-based Detection System**

Lane detection is a key problem in Advanced Driver Assistance Systems (ADAS) that attempt to warn drivers or assist in the driving process in potentially dangerous situations. Machine vision technology used in these systems must rely on the same visual cues as human drivers such as road boundaries, road color and texture, and lane marking color and type. Several sensing methods are used for lane understanding including vision (video camera), stereo imaging, LIDAR, RADAR, and Geographic Information Systems (GIS)/Global Positioning Systems (GPS)/Inertial Measurement Unit (IMU). Vision is the most prominent of the lane and road detection methods because markings are made for human vision, while LIDAR and GPS are important complements (13). Figure 2 shows a representation of a vision-based detection system (14).

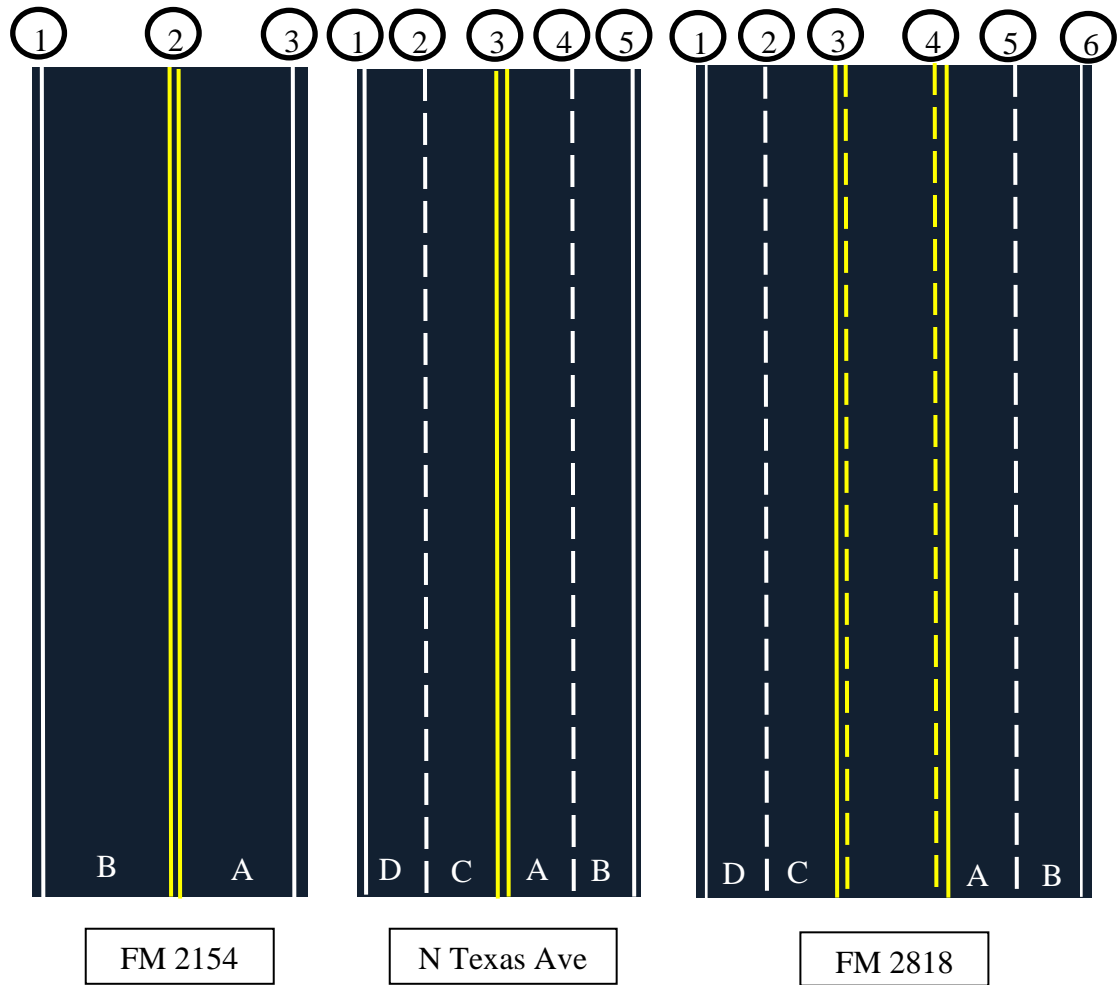
**Figure 3. Open Road Collection Locations**

For the open road data collection, three locations in the Bryan/College Station area were selected based on their different lane configurations. The multiple lane configurations allowed for more lane markings and lane routes to be included in the study following the recommendation of ASTM E691 which encourages involving more materials across more laboratories instead of a large number of results per material in a few laboratories (9). Figure 3 shows the locations with the lane markings numbered and the routes the test vehicle drove as letters.

The roadway sections are each between one and two miles long and were selected because of potential access to staging areas and turnaround locations. On FM 2154 the location was south of College Station from Greens Prairie Rd W to Hidden Springs Way. The N Texas Ave location was in Bryan from Wilhelm Dr to Arthur Davila Middle School. The third segment was on FM 2818 from La Brisa Dr in Bryan to F and B Road in College Station. These three sites were determined as adequate for the study because results were able to be obtained for 14 different pavement markings from

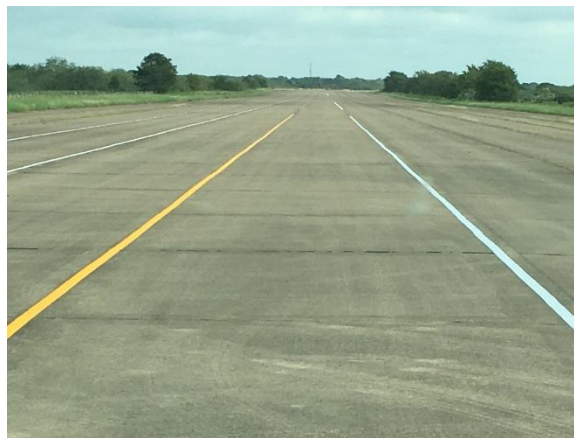
**Figure 4. Pavement Marking Layout for Closed Course Correlation Analysis**

The correlation portion of the closed course experiment used multiple pavement markings that were installed and characterized for another study at the TTI facility. These markings consisted of 7 levels of yellow and white preformed tape markings arranged in both solid line and skip line configurations. Each pavement marking was characterized in both daytime and nighttime lighting conditions. Data collected on the markings consisted of retroreflectivity, luminance, and color values. Machine vision quality scores were also obtained through the other study for the seven levels of yellow and white tape markings in daytime and nighttime conditions. However, since this data was from another study not designed for determining repeatability, there were not

enough quality scores collected to meet the minimum sample size requirements for determining repeatability for all of the testing conditions and marking configurations. These markings had been removed from the TTI facility at the time of the data collection for this study so further data collection was not possible. Figure 4 shows an example of the pavement marking layout at the TTI facility which was used in the closed course experiment.

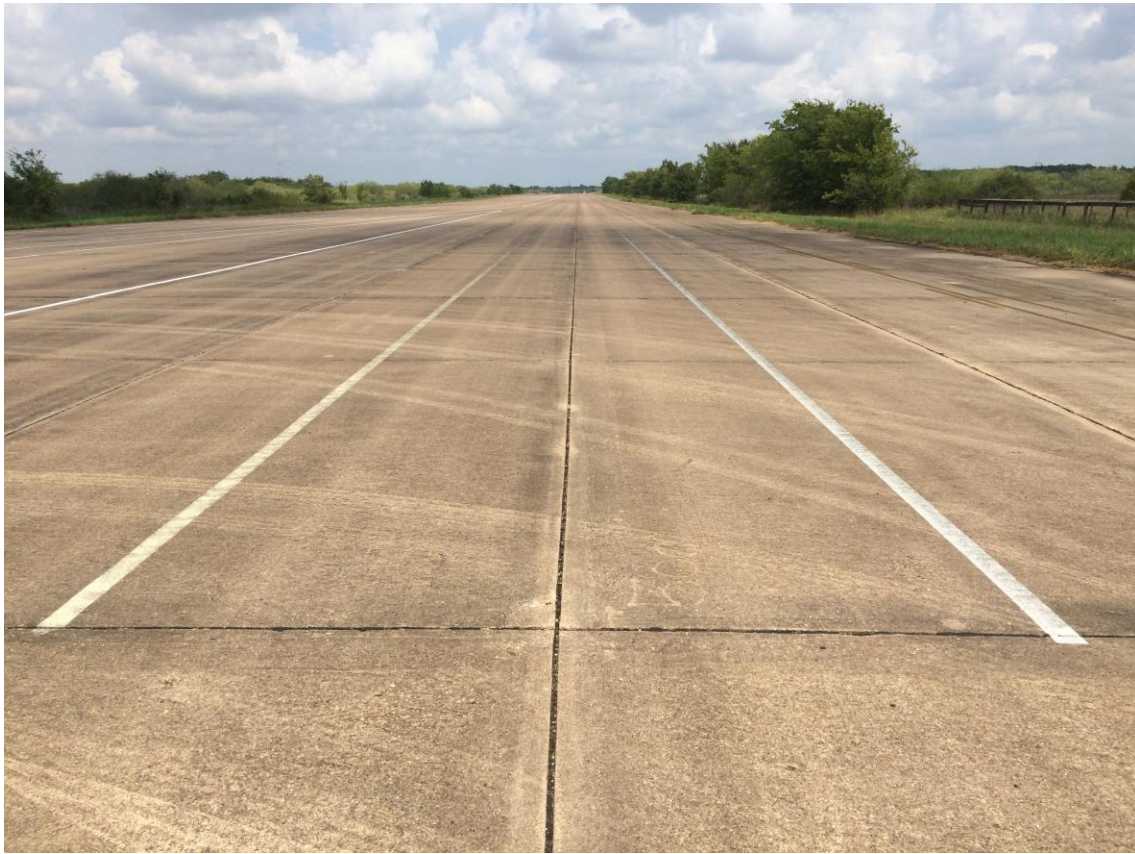
**Figure 5. Layout of Closed Course Pavement Markings for Repeatability Analysis**

Additional machine vision data was collected on another set of markings in the closed course conditions for the repeatability analysis. The machine vision data was collected in as close to the same conditions and method as the open road data as possible. There were six painted white solid pavement markings used for the closed course experiment. Some of these markings had been intentionally degraded when placed at the TTI facility in order to simulate markings of varying quality. An example of the marking layout is shown in Figure 5.

The markings were arranged in 3 sets of parallel lines at the TTI facility. The data collection vehicle was driven between each set of parallel markings in both directions. Driving through the markings in both directions allowed for the markings to be observed from both sides of the collection vehicle which served as multiple observation positions in the repeatability analysis. Along with observing each line from both sides of the collection vehicle, observing the markings in different travel directions was important because pavement markings characteristics can be direction dependent. Pavement marking evaluation characteristics, such as retroreflectivity and luminance,

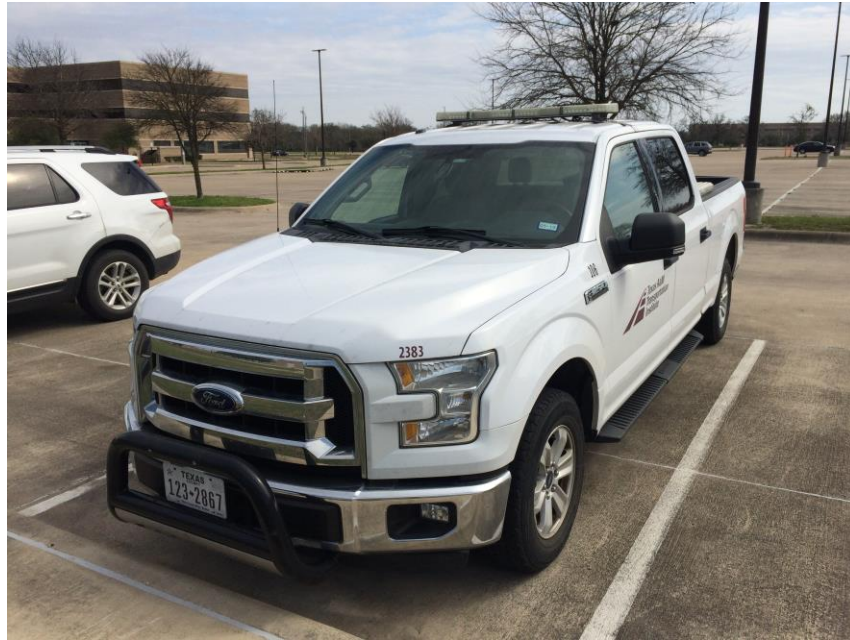
**Figure 6. Data Collection Truck**

All of the data for the open road portion of the study was collected using a TTI fleet vehicle equipped with the Mobileye machine vision sensor technology. The data collection system consists of a single machine vision camera mounted to the inside of the windshield below the rear-view mirror and an in-vehicle data unit located underneath the rear seat. The in-vehicle data unit has wi-fi connectivity and is responsible for recording and pushing the data to a cloud server where it is stored. The data collection vehicle, the position of the machine vision camera, and the in-vehicle data unit are shown in Figure 6 through Figure 9. The data collection system does not require any input from the driver of the vehicle during the data collection process.

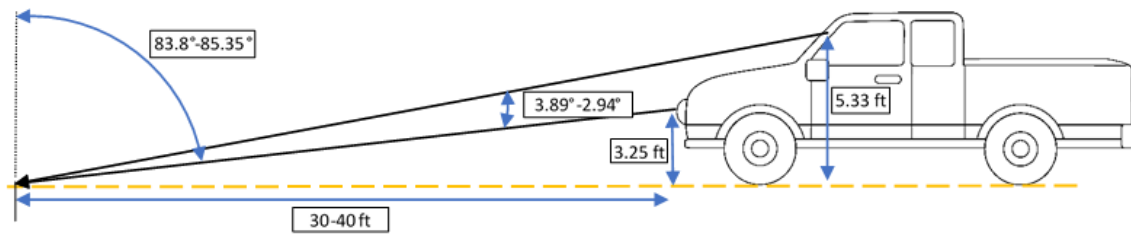
**Figure 10. Data Collection Truck Viewing Geometry**

Understanding the geometry of the machine vision camera is important to be able to compare the machine vision quality scores to the other pavement marking characteristics such as retroreflectivity. The camera is positioned in the middle of the data collection vehicle at a height of about 64 inches from the ground. The headlamps of the data collection vehicle are located at a height of 39 inches from the pavement. According the user guide the Mobileye camera has an object maximum detection range of 80 meters (262 feet) and a view field of 40 degrees by 30 degrees (width x height) (15). However, the actual look ahead distance associated with the quality score assigned to the pavement markings by the machine vision camera is not explicitly stated. From another study it was determined that the sweet spot for the Mobileye machine vision camera to evaluate pavement markings is 30 to 40 feet in front of the vehicle (16). The distance at which the machine vision camera evaluates the lane marking and assigns the quality score is important in calculating the observation angle and entrance angle for comparison to the standard 30-meter geometry of the retroreflectometer used in this study. The angles were calculated using the 30 to 40-foot viewing distance discussed above. The observation angle was calculated to be between 2.94 and 3.89 degrees and the entrance angle was between 83.8 and 85.35 degrees. Figure 10 shows the viewing geometry of the data collection vehicle with the machine vision camera.

The observation angle is a function of the distance between the headlamps and the machine vision camera along with the viewing distance. While the entrance angle is a function of the height of the headlamps and the viewing distance. A smaller observation angle increases the observed luminance as the light source (headlamps) and receptor (driver or machine vision camera) are closer together. A smaller entrance angle would also result in increased luminance as the light source and reflector are more in line with each other. The data collection vehicle has higher headlamps than the vehicle used to construct the standard 30-meter geometry along with a higher receptor height. When the geometry is calculated with the 30 to 40 foot viewing distance this results in a smaller entrance angle and a larger observation angle than the 30-meter geometry.

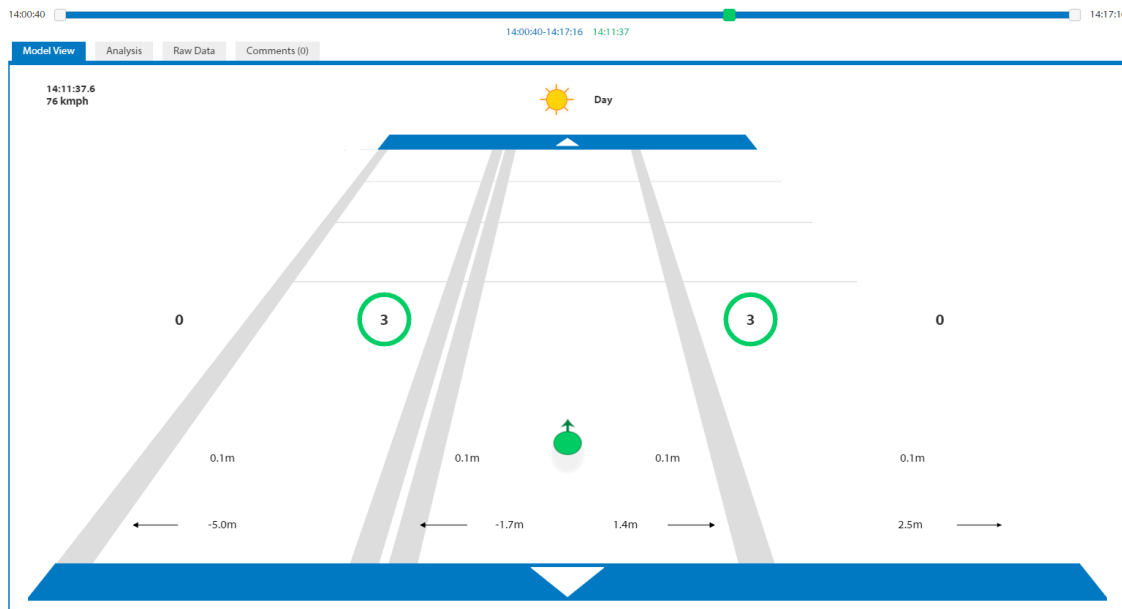
**Figure 11. Model View Display of Machine Vision Data**

The data collected by the ADAS machine vision camera was pushed to a cloud server where it is recorded in tenth of second increments. The server has a web interface that includes a model view showing what the machine vision detected and the raw data files available for download. The model view is shown in Figure 11 and the raw data format on the cloud server is shown in Figure 12. The model view shows the light condition the data was collected in (day or night), a visual representation of the lane markings as detected by the machine vision camera, the quality score of the lane markings, dimensions of the lane markings, and the distance from the machine vision camera to the lane markings. The raw data file shows all of the data collected on the lane markings along with the other data recorded about the data collection vehicle by the onboard system.

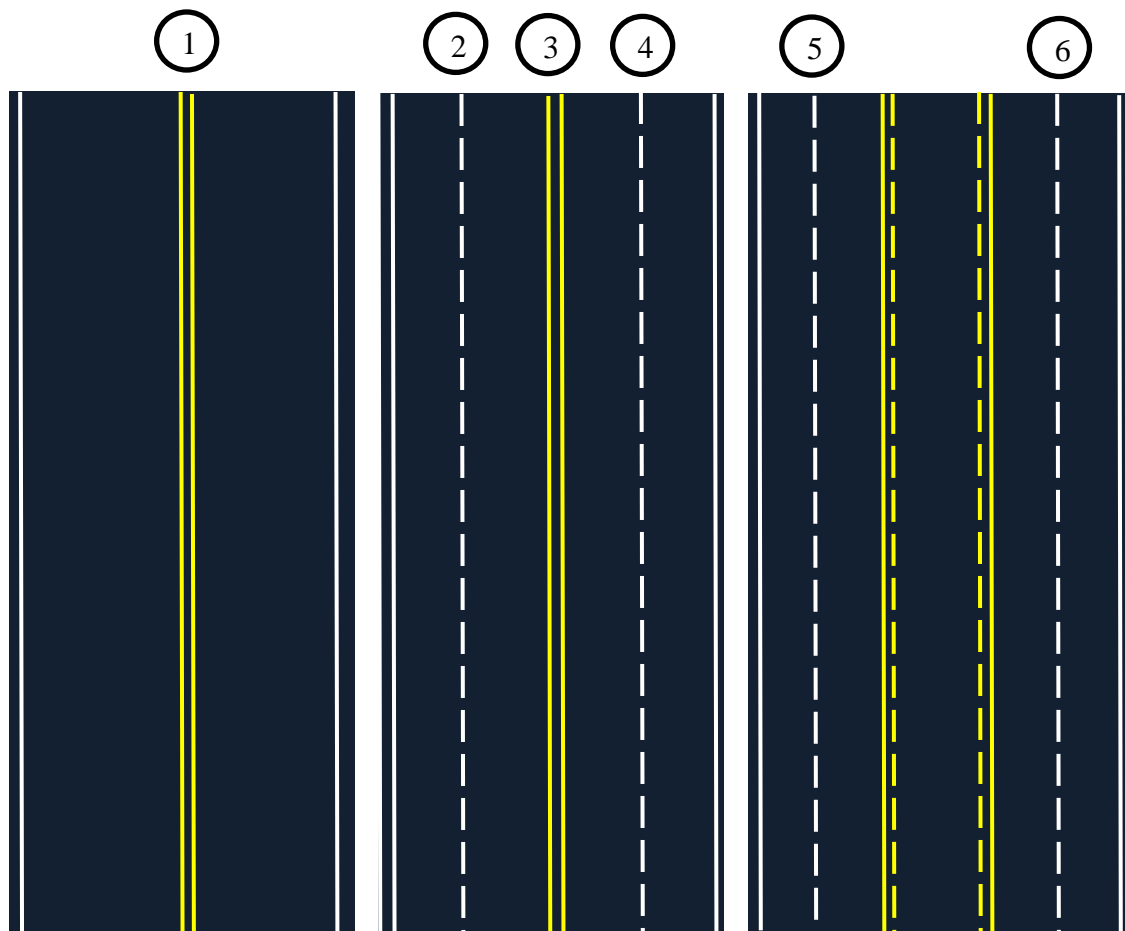
**Figure 13. Open Road Pavement Markings with Repeatability Standard Deviation**

The open road pavement markings analyzed for repeatability are shown in the figure below.

Lane Marking 1 was the double yellow centerline marking on FM 2154 located outside of College Station, TX. The pavement marking was observed from two positions both on the left side of the data collection vehicle as the road segment was traveled in

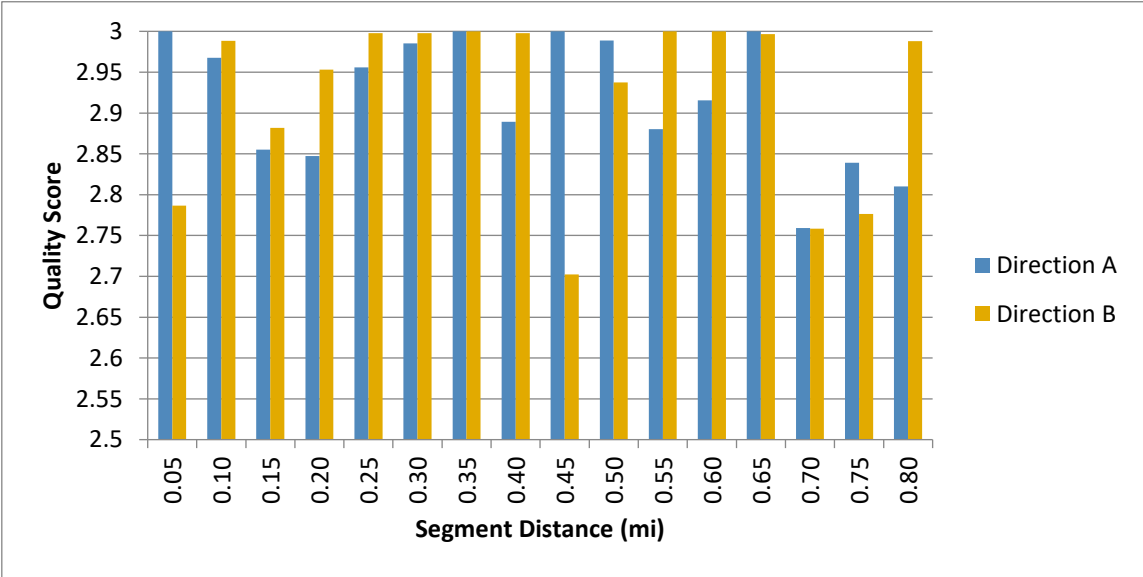
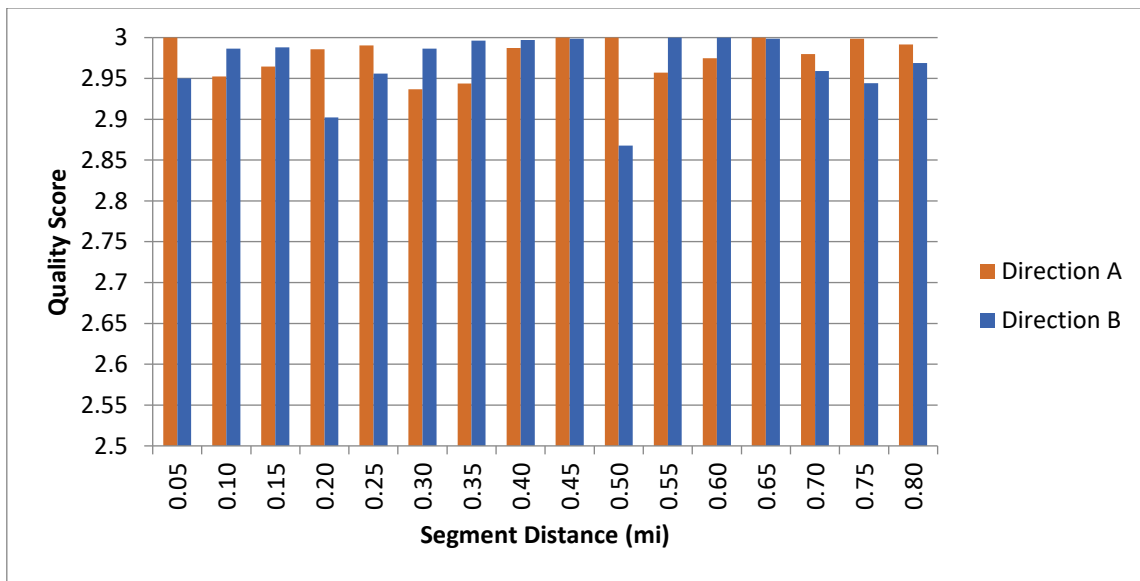
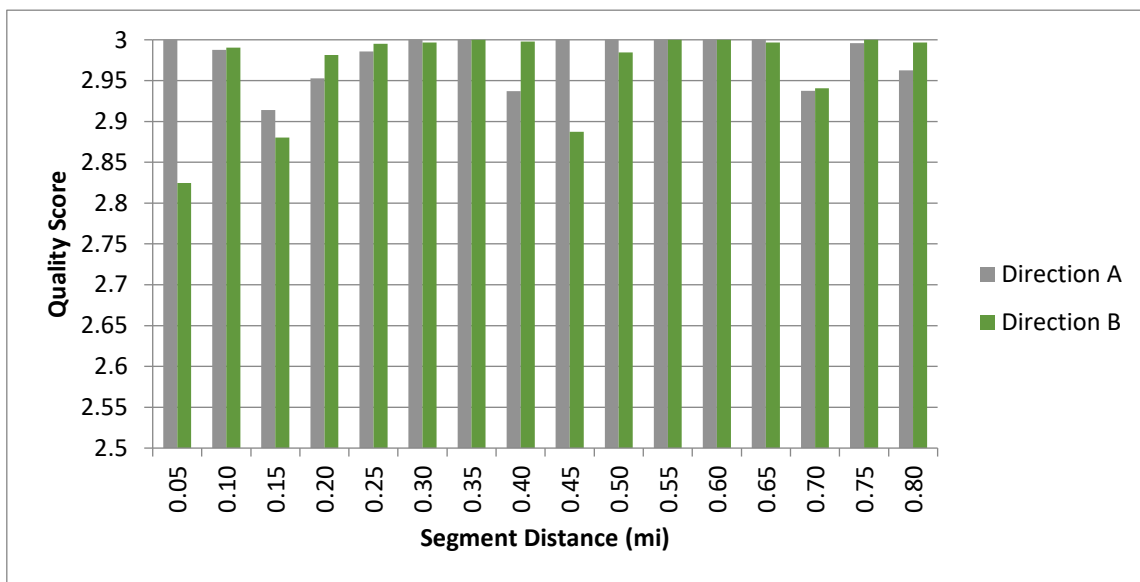
**Figure 14. Daytime Quality Score by Direction**

**Figure 15. Nighttime Quality Score by Direction**

**Figure 16. Overcast Quality Score by Direction**

The comparison of the quality scores collected in each travel direction did not show a clear trend for a difference in quality score based one direction versus the other. This observation held true for all of the markings observed in different directions. Because of this both directions of data were combined for use in the repeatability analysis.

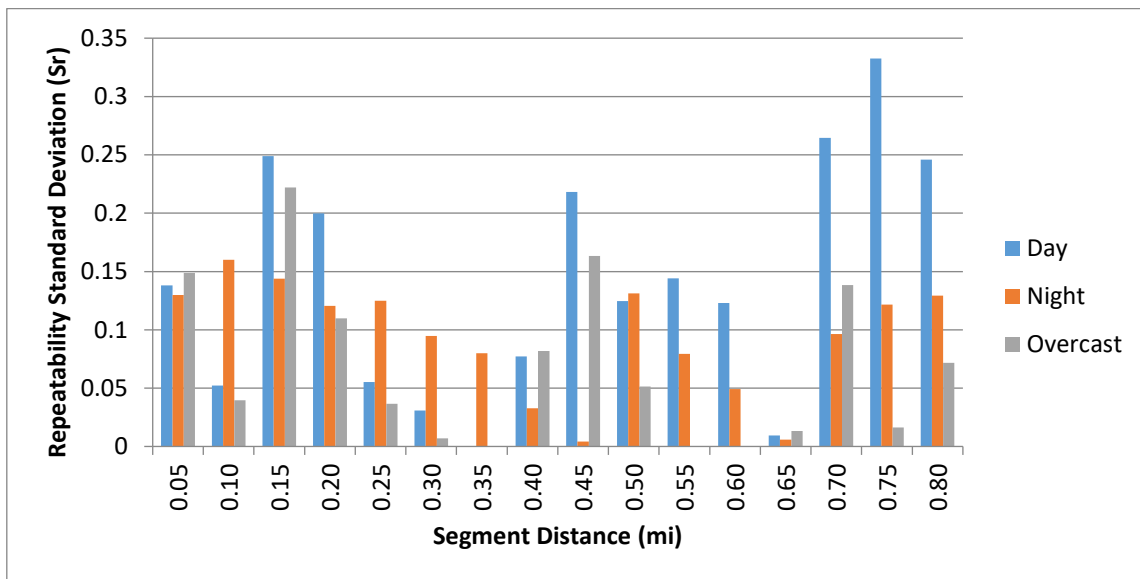
**Figure 17. Lane Marking 1 FM 2154 Segment Repeatability Standard Deviation**

The repeatability standard deviation is shown in Figure 17 for each segment under each of the three observation conditions. At this location, the repeatability standard deviation appears to vary for many of the analysis segments based on the condition the data was collected in day, night, or overcast. For the majority of the segments, the daytime collection condition resulted in a higher repeatability standard

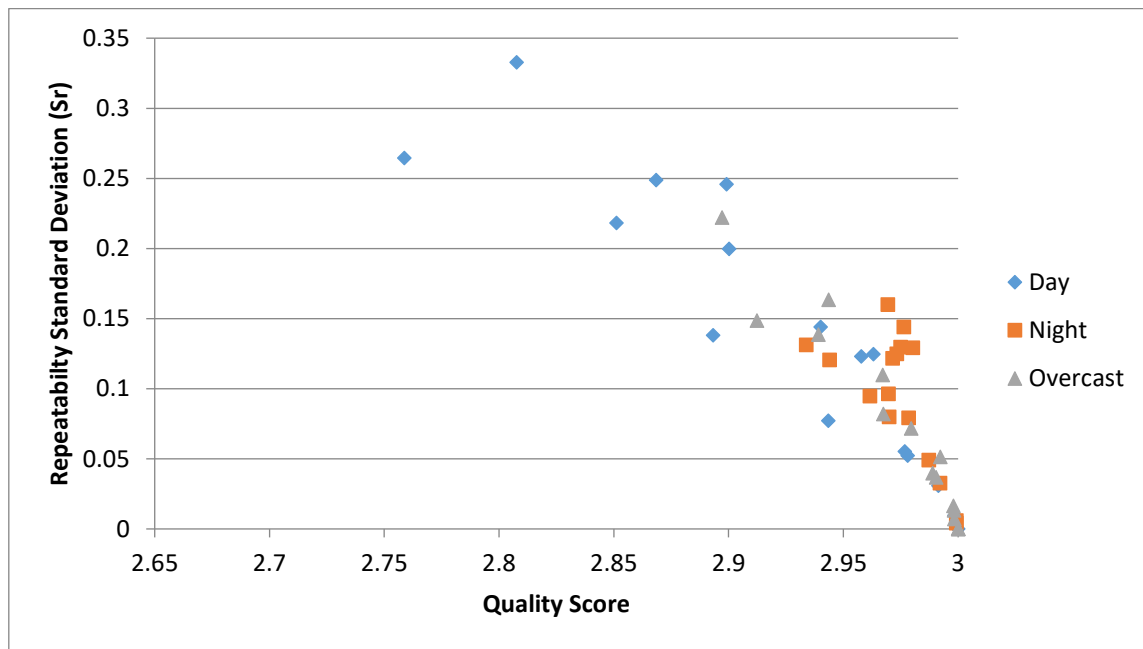
**Figure 18. Lane Marking 1 Repeatability Standard Deviation vs. Average Quality Score**

deviation than the other collection conditions. The relationship between the average quality score of each lane marking segment and the repeatability standard deviation for each segment is shown in Figure 18. The figure shows that for each of the observation conditions the repeatability standard deviation decreases as the average quality score increases.

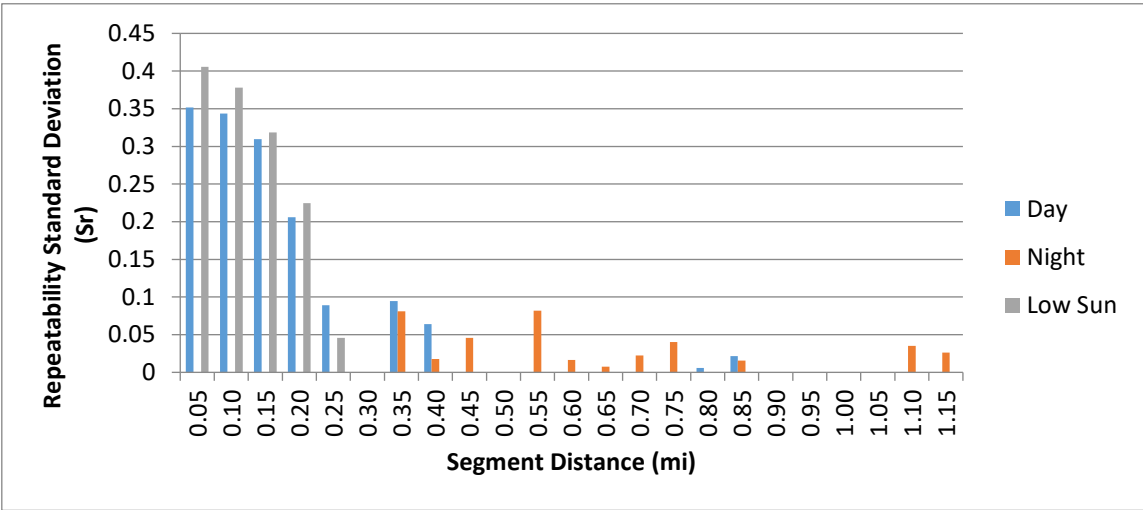
**Figure 19. Lane Marking 2 N Texas Ave Segment Repeatability Standard Deviation**

The repeatability standard deviation is shown in Figure 19 for each segment under each of the three observation conditions. At this location the repeatability standard deviations for the first segments are much higher than the end segments particularly in the day and low sun collection conditions. This could be due to the presence of shadows from trees close by the edge of the roadway at this location. For the segment with high repeatability standard deviations the low sun condition has a higher value in most instances. The lack of a bar for a condition indicates that the repeatability standard deviation is equal to zero, which means that the quality score was the same for each sample and observation position in that segment. The relationship between the average quality score of each lane marking segment and the repeatability standard deviation for

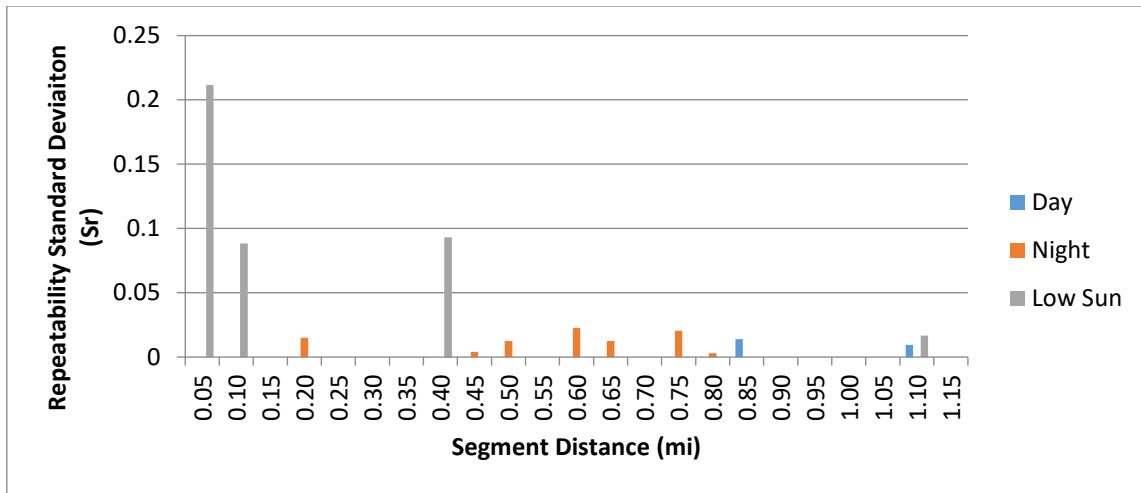
**Figure 21. Lane Marking 3 N Texas Ave Segment Repeatability Standard Deviation**

The repeatability standard deviation is shown in Figure 21 for each segment under each of the three observation conditions. This section had low repeatability standard deviations across all collection conditions and segments except for a few segments which had higher values in the low angle sun condition. The lack of a bar for a condition indicates that the repeatability standard deviation is equal to zero, which means that the quality score was the same for each sample and observation position in that segment. The relationship between the average quality score of each lane marking segment and the repeatability standard deviation for each segment is shown in Figure 22. The figure shows that for each of the observation conditions the repeatability standard deviation decreases as the average quality score increases.

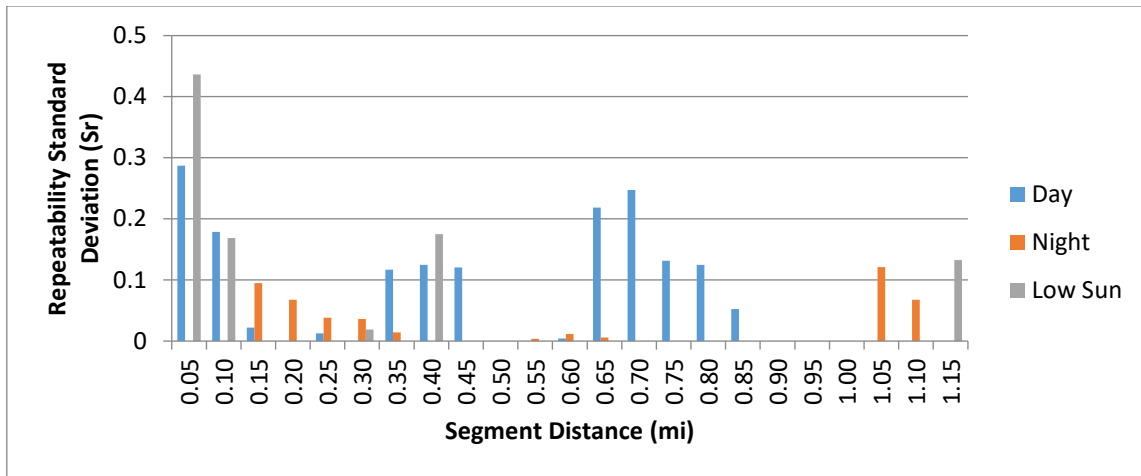
**Figure 23. Lane Marking 4 N Texas Ave Segment Repeatability Standard Deviation**

The repeatability standard deviation is shown in Figure 23 for each segment under each of the three observation conditions. This location shows a similar pattern to lane marking 2 where the segments at the beginning have higher repeatability standard deviations. It also shows the same trend as previous markings where the daytime condition results in the higher repeatability standard deviations. The lack of a bar for a condition indicates that the repeatability standard deviation is equal to zero, which means that the quality score was the same for each sample and observation position in that segment. The relationship between the average quality score of each lane marking segment and the repeatability standard deviation for each segment is shown in Figure 24. The figure shows that for each of the observation conditions the repeatability standard deviation decreases as the average quality score increases.

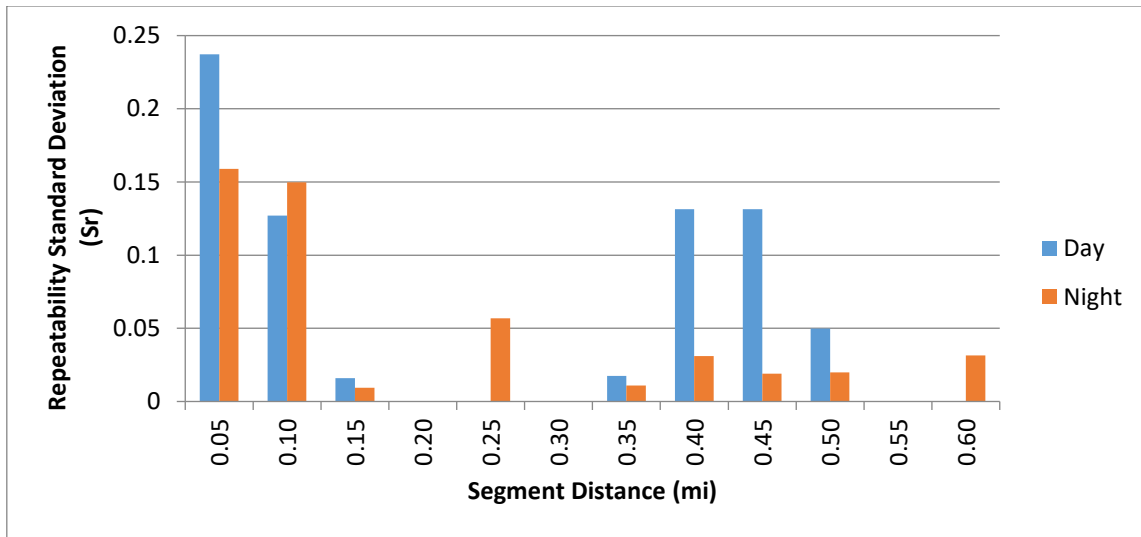
**Figure 25. Lane Marking 5 FM 2818 Repeatability Standard Deviation**

The repeatability standard deviation is shown in Figure 25 for each segment under each of the three observation conditions. Again, at this location, by observation, the data shows that the daytime collection condition repeatability standard deviation is usually higher than the nighttime values. The relationship between the average quality score of each lane marking segment and the repeatability standard deviation for each segment is shown in Figure 26. The figure shows that for each of the observation conditions the repeatability standard deviation decreases as the average quality score increases.

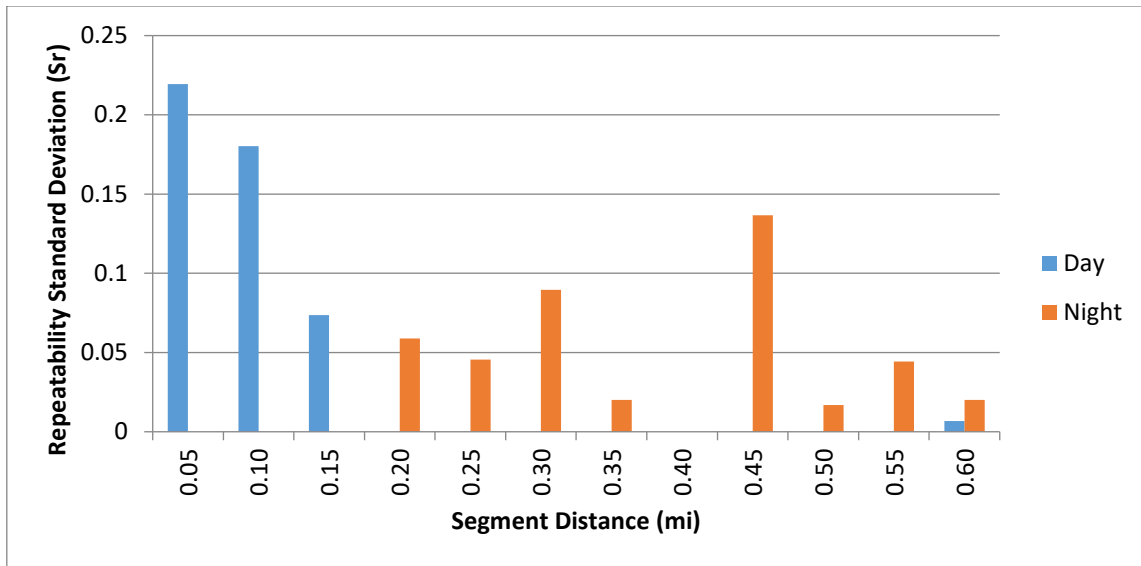
**Figure 27. Lane Marking 6 FM 2818 Repeatability Standard Deviation**

The repeatability standard deviation is shown in Figure 27 for each segment under each of the three observation conditions. This location is interesting as almost all of the segments only have repeatability standard deviations for one of the two collection conditions. The lack of a bar for a condition indicates that the repeatability standard deviation is equal to zero, which means that the quality score was the same for each sample and observation position in that segment. More segments have a repeatability standard deviation in the nighttime condition than the daytime condition which is different from previous lane markings where the daytime condition would often show the higher repeatability standard deviation. The relationship between the average quality score of each lane marking segment and the repeatability standard deviation for each segment is shown in Figure 28. The figure shows that for each of the observation

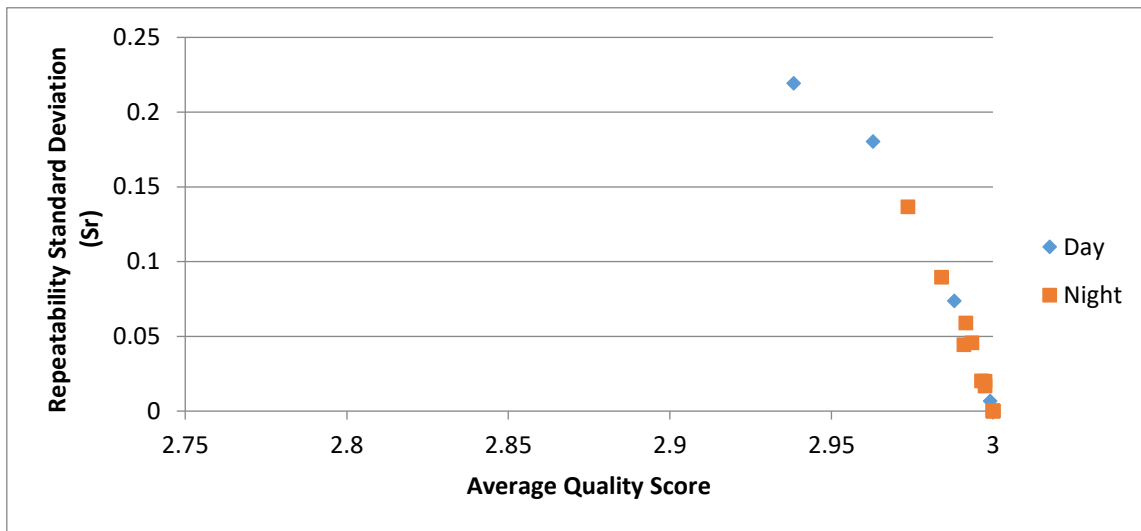
**Figure 28. Lane Marking 6 Repeatability Standard Deviation vs. Average Quality Score**

conditions the repeatability standard deviation decreases as the average quality score increases.

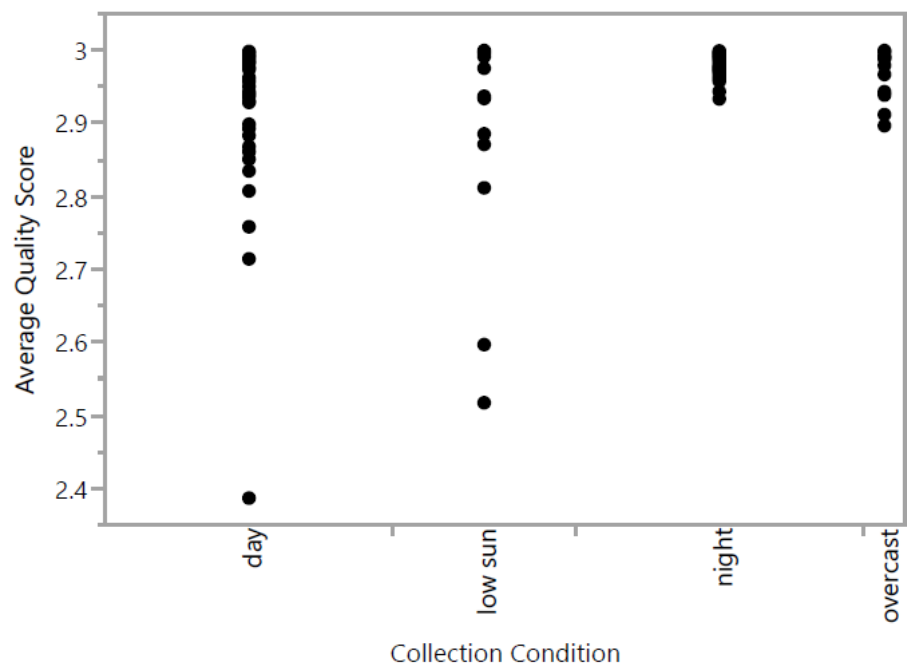
**Figure 30. Average Quality Score by Collection Condition**

test for the effects of collection conditions on the quality score and repeatability standard deviation. All of the average quality scores and repeatability standard deviations for each segment and collection condition were combined into one data set for this analysis. The means of the average quality scores and repeatability standard deviations were compared using the Tukey’s HSD test. This method compares the means of multiple groups and allows for the conclusion to be made whether the means are significantly different from each of the other groups. This test was performed for both the average quality score and the repeatability standard deviation. The results are shown in Figures 30 to Figure 33.

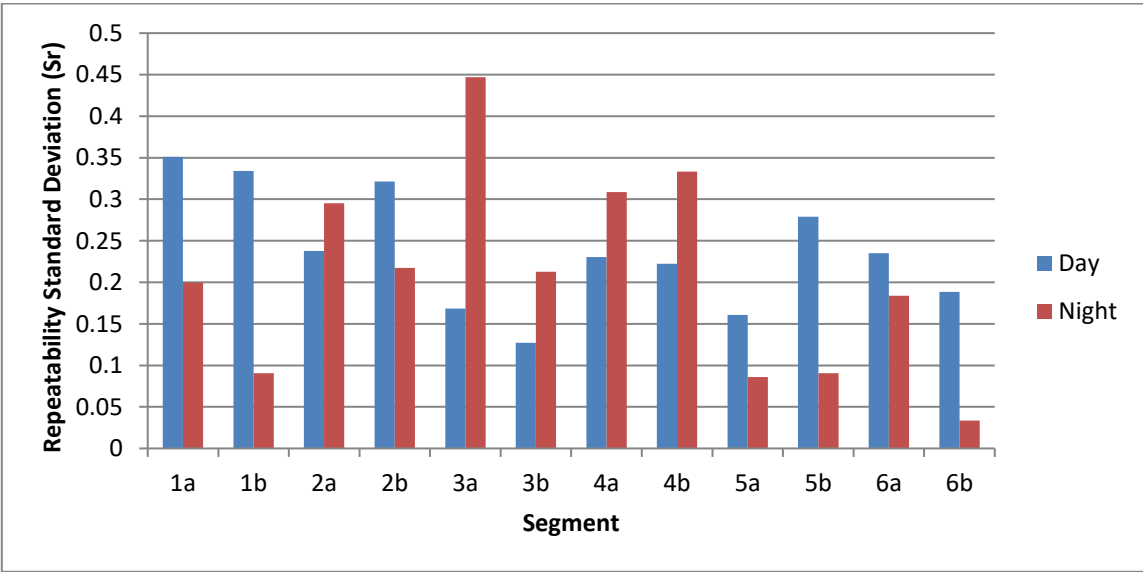
**Figure 34. Closed Course Repeatability Standard Deviation by Segment**

Along with the six open road lane markings, six more closed course pavement markings were analyzed for repeatability. Each of the closed course markings was a solid white lane marking. These markings were divided in half for analysis purposes resulting in 12 total segments from all six of the markings. The first half of each marking was designated as “a” while the second half was labeled “b” for organizational and data presentation purposes. The repeatability standard deviation for each marking segment is shown in Figure 34.

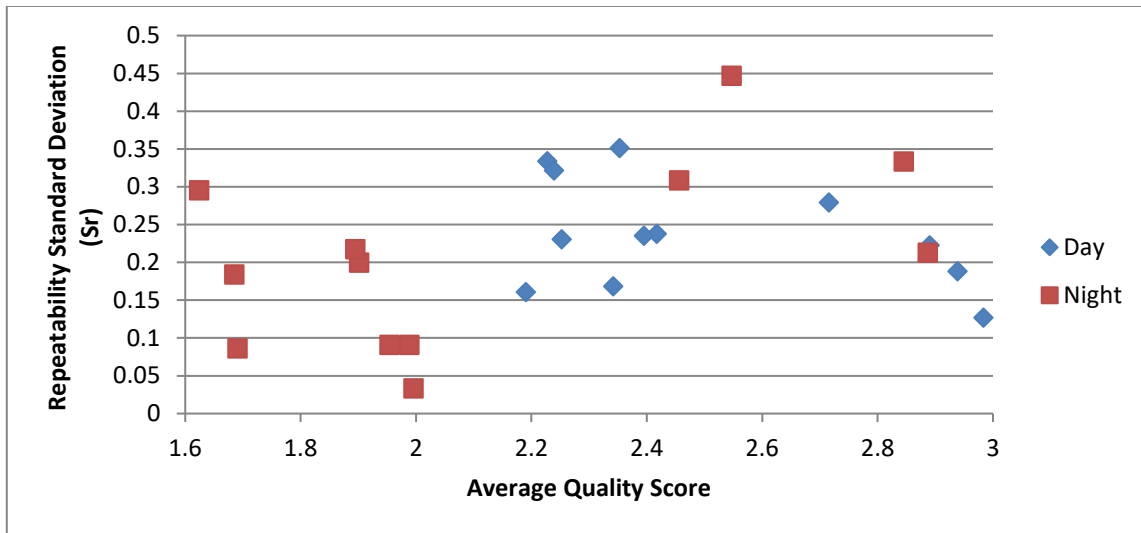
**Figure 35. Closed Course Repeatability Standard Deviation vs. Average Quality Score**

The relationship between the average quality score and the repeatability standard deviation was again plotted as it was for the open road data. The daytime data appears to exhibit close to the same relationship as the open road data where the repeatability standard deviation decreases as the average quality score increases; however, the nighttime data does not appear to follow this relationship as clearly as in the open road condition.

This difference in the relationship between the repeatability standard deviation and average quality score for the nighttime data could be a result of the lower average quality scores for the markings resulting in increased variability and higher  $S_r$  due to the presence of both lower and higher quality markings. The closed course nighttime average quality scores were consistently lower than the corresponding daytime average quality score for almost all of the closed course segments as shown in Figure 36.

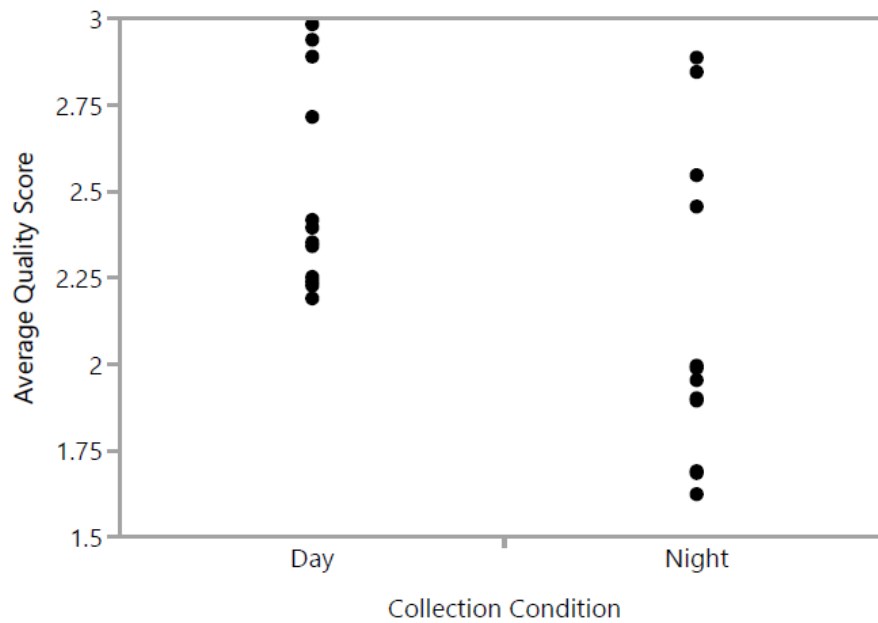
**Figure 37. Closed Course Average Quality Score by Condition**

The same comparison using the Tukey's HSD test performed on the open road data was also applied to the closed course data. For the closed course data, the means of the average quality score for the daytime and nighttime condition were significantly different just as they were for the open road data. However, the means of the repeatability standard deviations were not significantly different between the two collection conditions. The results of the JMP software outputs are shown Figures 37 through 40.

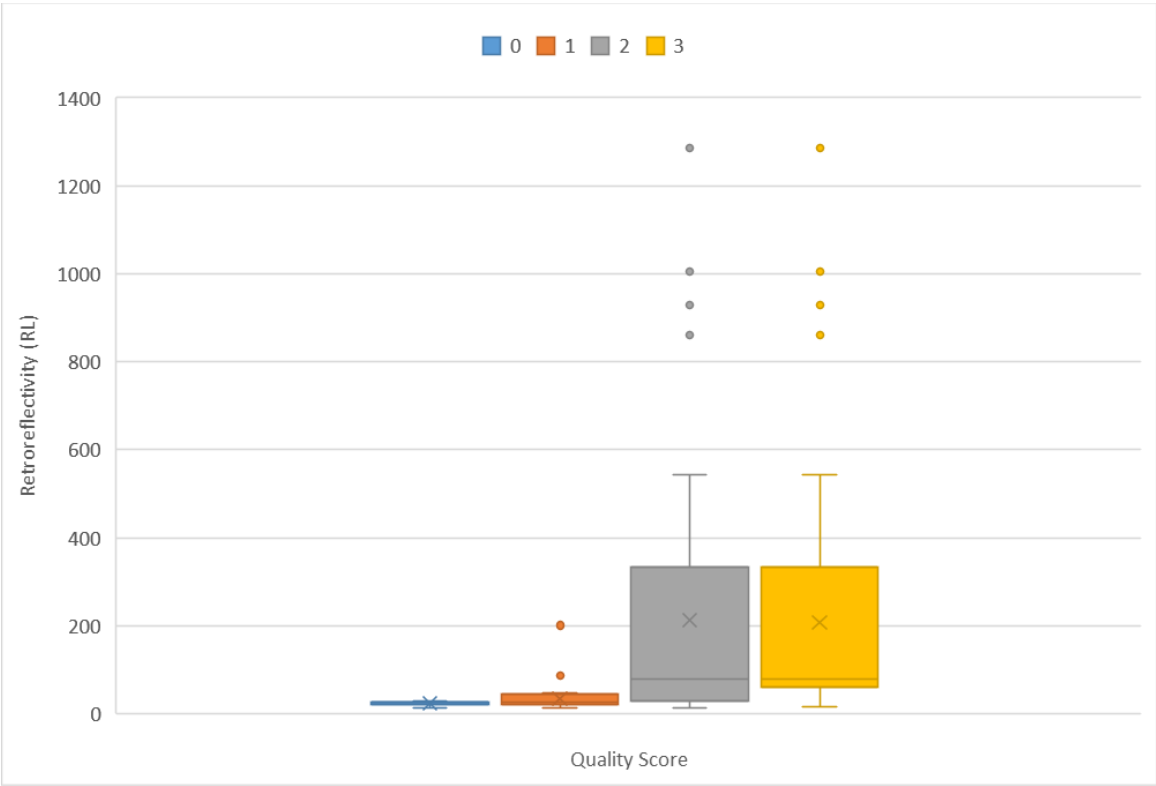
**Figure 41. Box-and-Whisker Plot Retroreflectivity vs. Quality Score**

collected in the different conditions. This analysis sought to understand the relationship between the average quality scores assigned by the ADAS machine vision camera and the measured retroreflectivity of the pavement markings. The measured retroreflectivity of the closed course pavement markings ranged from 14.14 mcd/m<sup>2</sup>/lux to 1285.88 mcd/m<sup>2</sup>/lux. For this analysis the average quality score for each individual data collection run was paired with the measured retroreflectivity for the pavement marking resulting a total of 597 paired observations. A box-and-whisker plot was then constructed to compare the mean and range of the measured retroreflectivity values that were assigned each quality score value by the machine vision.

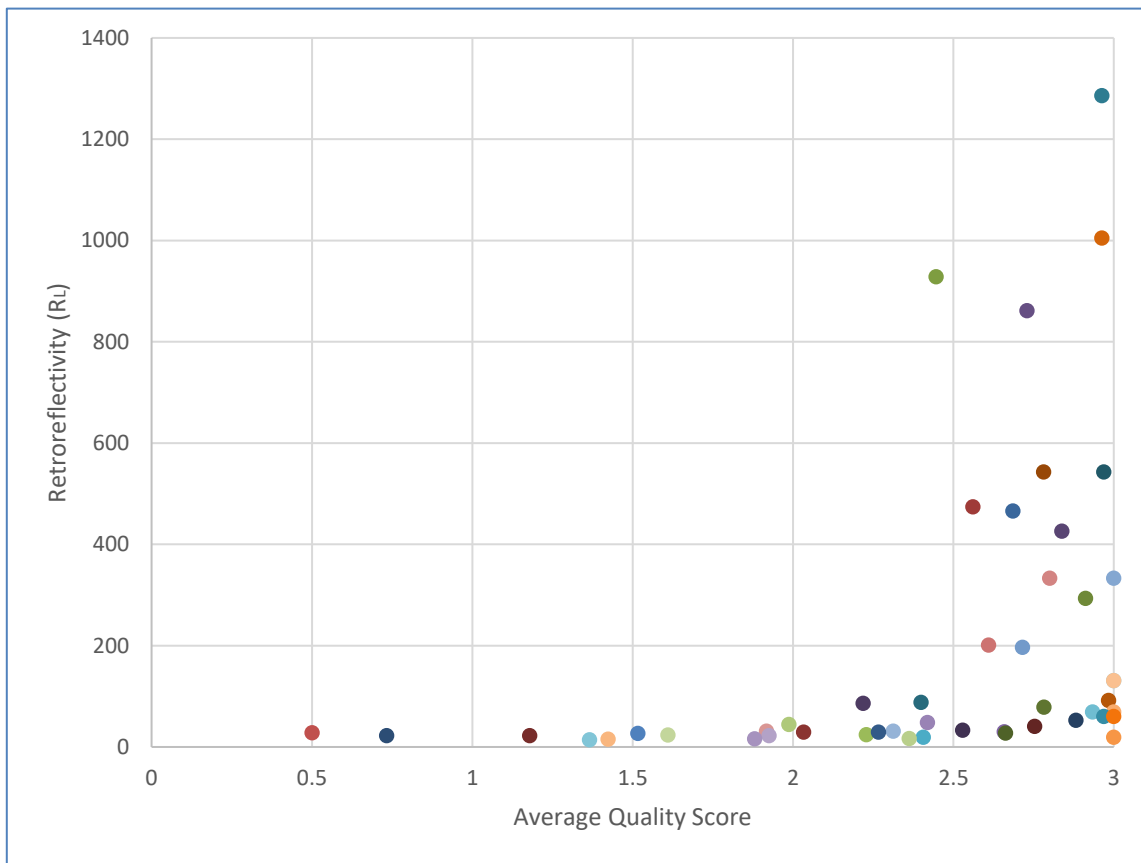
**Figure 42. Retroreflectivity vs. Average Quality Score**

Another chart comparing the retroreflectivity for each closed course pavement marking with its average quality score for all the data collection runs was also created to observe any potential relationships. Figure 42 shows the results of this chart where each point represents each of the different closed course pavement markings measured for retroreflectivity and assigned a machine vision quality score in both the northbound and southbound direction.
